A SURE WAY TO EMPTY YOUR WALLET

ACQUIRING THE MACHINING, COMPONENT REBUILDING SERVICES
& REPLACEMENT PARTS NEEDED FOR THE RESTORATION OF
A 1932 PACKARD STANDARD EIGHT ENGINE

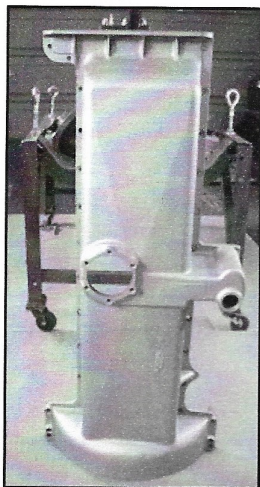
Crankcase: Because this component is made of cast aluminum, magna-flux testing couldn't be performed. Due to the softness of aluminum, the crankcase was soda blasted with non-abrasive ground walnut shell media. While the blasting did the job of cleaning the crankcase, mild discoloration that occurred over several

decades of exposure to grease, grime and oil remained.

All main bearing caps and saddles were in fantastic shape. It was determined through using Plastigauge that clearances between the bearing surfaces and the crankshaft journals were well within Packard specifications.
